Designing Means of Access and Related Access Aids

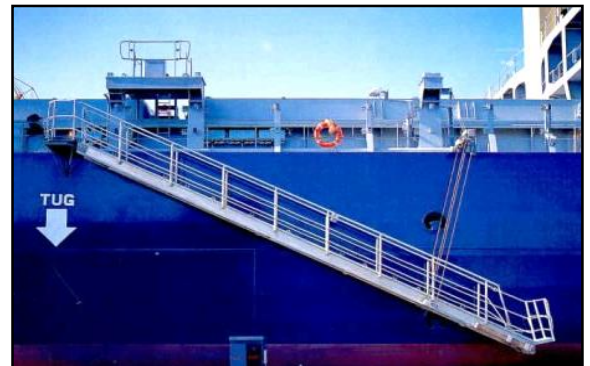
Traditional maritime design practices allowed for stairs of up to 60° inclination. However, as the angle of inclination of stairs increase, the stair tread gets narrower and the riser height increases. This in turn decreases the amount of tread available to step on, especially during descent, thereby increasing the likelihood of a crew member's foot slipping from, or missing, a step.

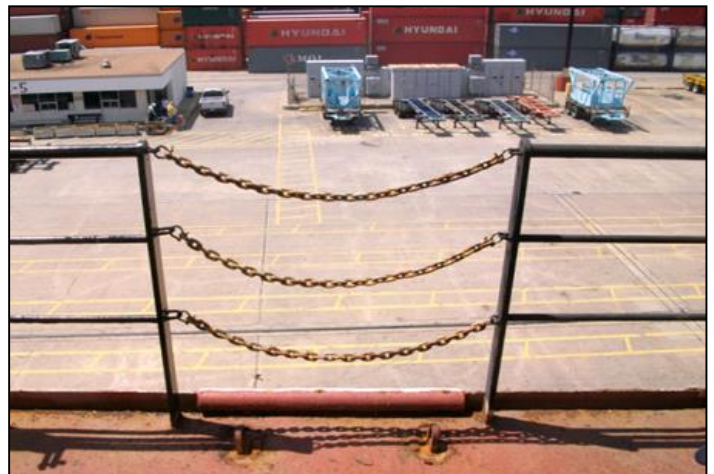
male, especially those from the Northern European and North American regions. At the lower limit, it is judged more likely for taller crew members to rotate over the rail, as the center of mass (for a 95% Northern European and North American male) is about three inches higher than the height of the rail.

When the center of mass of a human body acts above a guardrail, a person falling against that guard rail will have a greater tendency to rotate over the top of the railing. Further, when the center of mass of a human body acts below the top of a rail that person would have a tendency to rotate under the railing. This action (rotating under the top rail), along with the provision of intermediate rail(s), helps prevent a fall either over or under the top safety rail.

The provision of lower guardrail heights puts taller offshore workers or mariners at a safety dis-advantage. When considering the taller potential worker population, a guardrail height of 42 inches (1070 mm) can help protect approximately 99% of all potential workers (men and women) from falls over the rail.

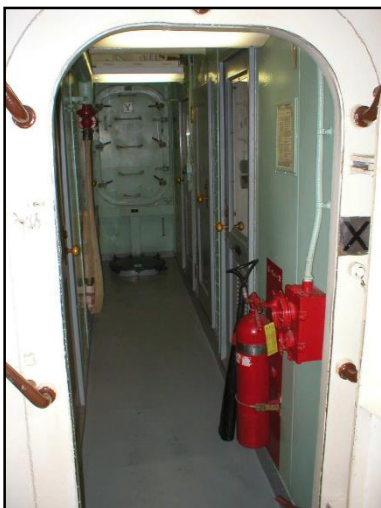
A major concern related to the simple task of walking down a passageway is the presence of bulkhead mounted equipment. Items mounted on a bulkhead, such as an electrical junction box or a fire hose box and fittings, present safety hazards. Further, it is advisable that passageways be kept free of any bulkhead-mounted objects if a passageway has any of the following characteristics (Zohar, 1978):

Where minimum widths are offered in walkway and passageway design standards they define the minimum clear walking surface. This is different than the dimensions of the walkways or passageway bulkheads with a walking area impeded by items mounted on walkway or passageway bulkheads. There should be suitable upper clearance for items mounted on a walkway or passageway bulkhead to prevent a person from accidentally walking into these items (Zohar, 1978).
